## 2015 Facilities Master Plan

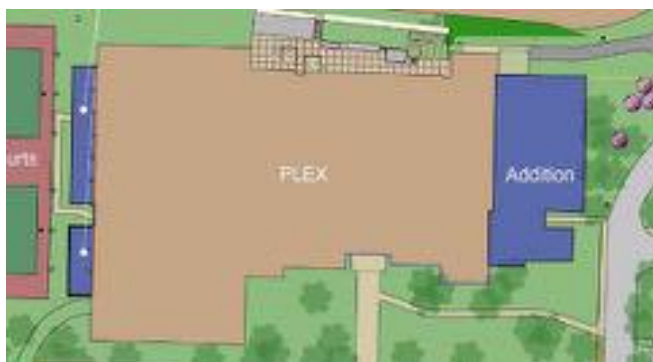
### The PLEX

Over the years since this building was constructed, student enrollment has grown, faculty and staff have changed and needs have evolved, but the PLEX has not kept pace. Instead, like other facilities on campus, maintenance has been deferred and improvements have been postponed to the point of having to close the natatorium portion

due to an unsafe roof structure. Student recreation and athletic facilities are important to the success of a campus and some would say, vital, to the ability of a university to attract students. The PLEX falls short in this area and is in urgent need of improvement.

The master plan proposes a modest start to these improvements by recommending an addition on the location of the natatorium designed to accommodate an auxiliary gymnasium, a weight machine/exercise area for student use, a classroom and coaches' offices. Additional storage space is proposed at the west side of the fieldhouse. If funds permit, the following renovations should also be implemented:

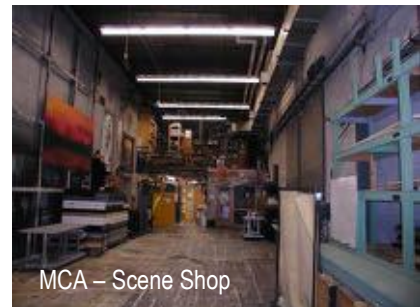
MCA – Scene Shop

The scene shop, while efficient, does not have enough storage or staging area when multiple productions are in preparation. Presently surplus scenes/props are stored off site in an unconditioned space leaving them susceptible to damage; additional building square footage for the scene shop is recommended. Additional power drops (from ceiling) and sink/clean up space would offer immediate improvements at minimal cost to the scene shop. The ladder stage left (looking toward stage from scene shop) should be replaced to improve safety and mobility of student staff. The exterior scene shop door should be replaced with an insulated overhead door for greater mobility of scene building material and gear from traveling shows. The exterior loading dock should be a covered exterior space and the aged dock lift replaced to assist the needs of visiting shows where multiple trailers might be required.

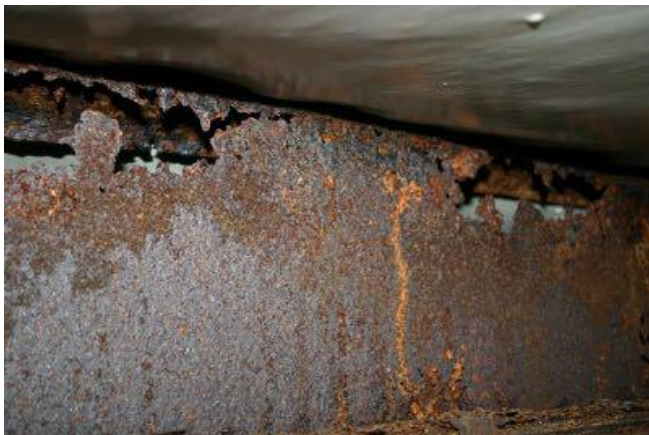
Corroded Steel Roof Purlin

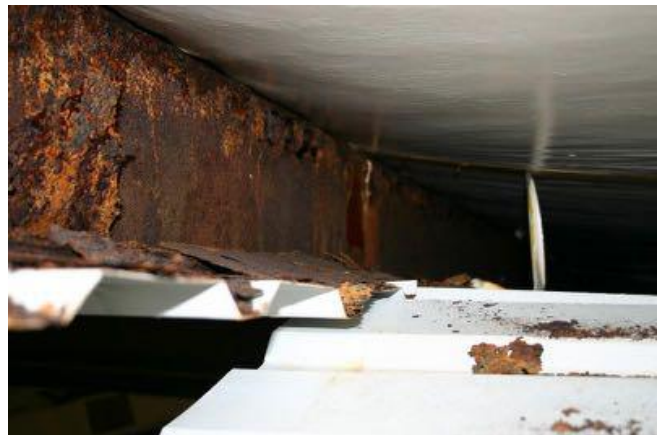
Corroded Steel Roof Purlin

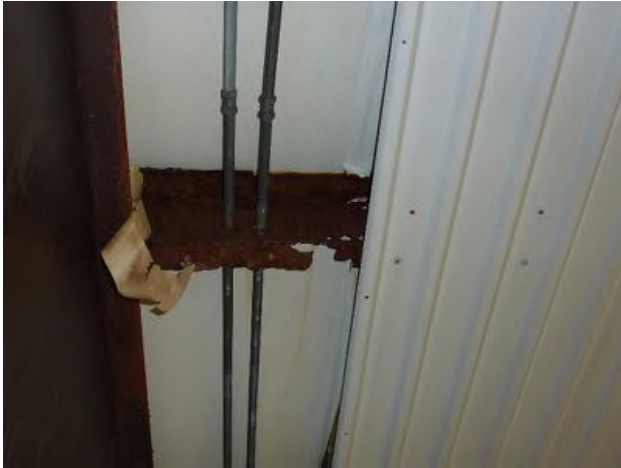
Corroded Steel Roof Purlin

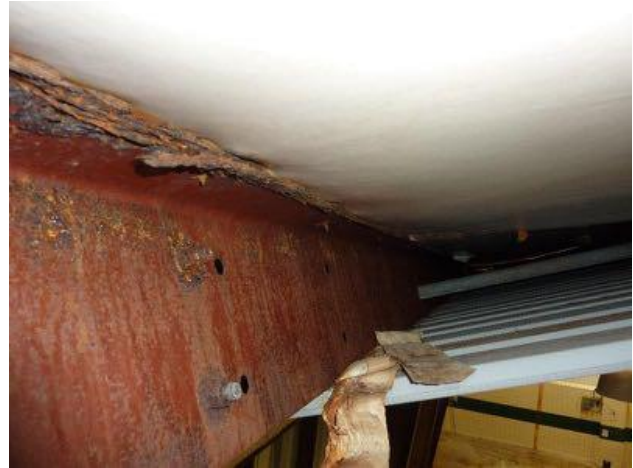
Corroded Steel Roof Purlin

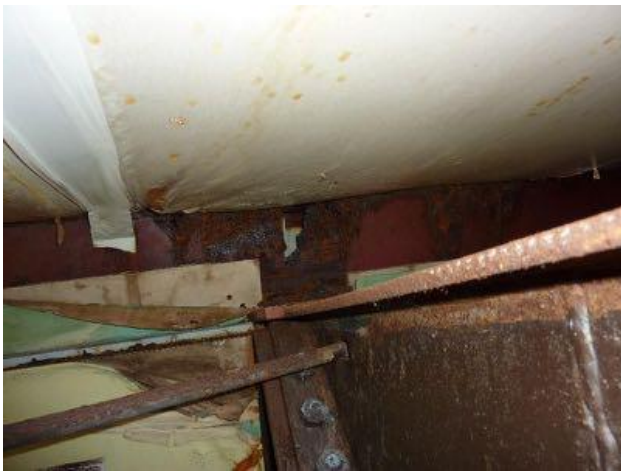
Corroded Steel Roof Purlin (beyond)

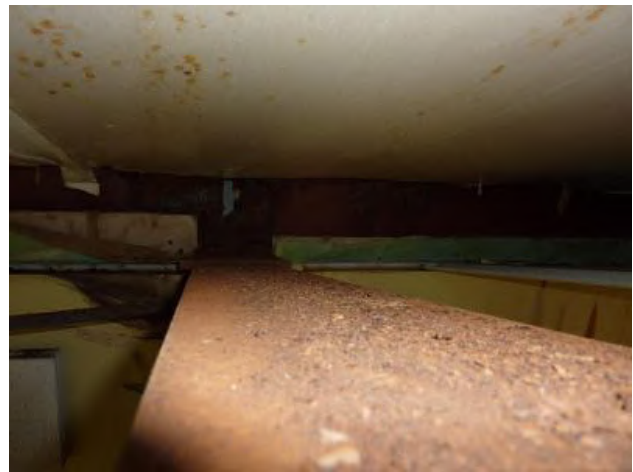
Top Surface of Gabled Portal Frame Girder

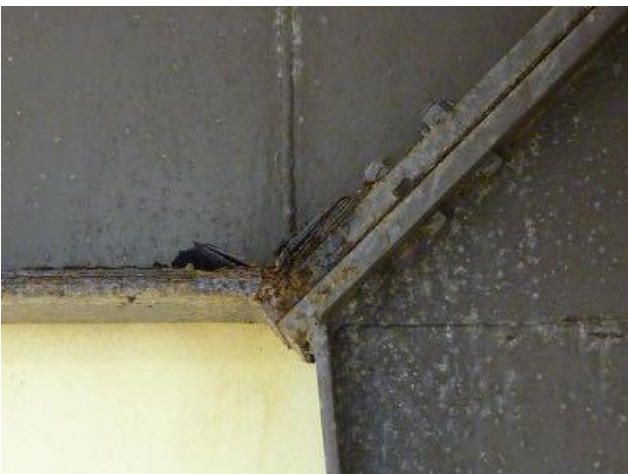
Corroded Flat Portal Frame Girder (west col line)

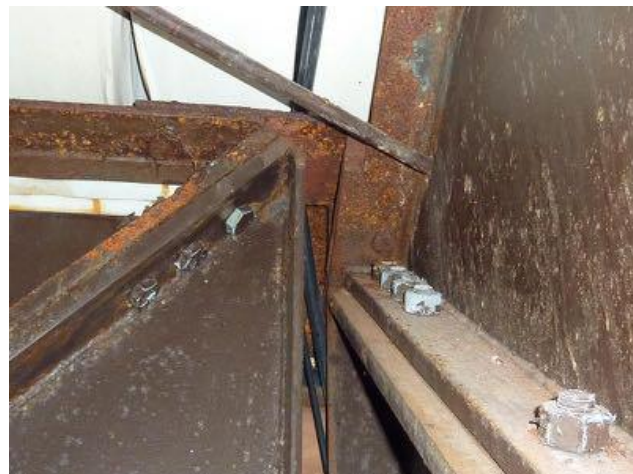
Corroded Flat Portal Frame Girder (west col line)

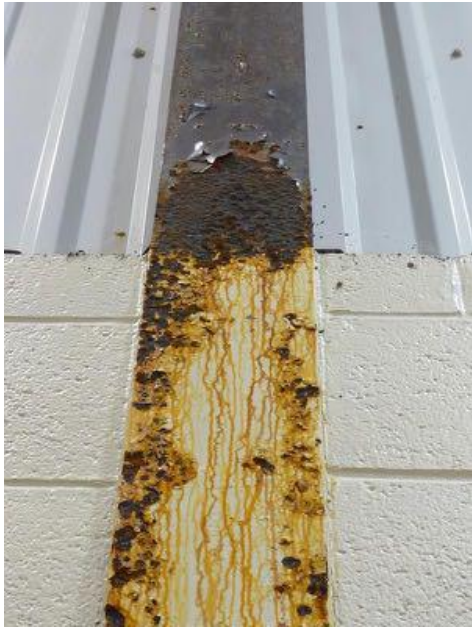
Corroded North Load Bearing  
Wide Flanged Wind Column

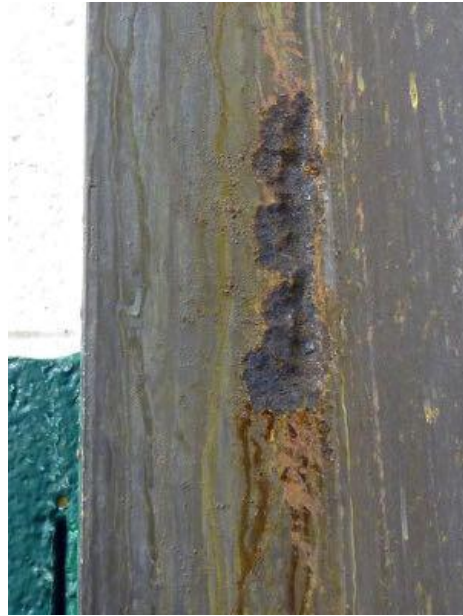
Corroded Gabled Portal Frame Column

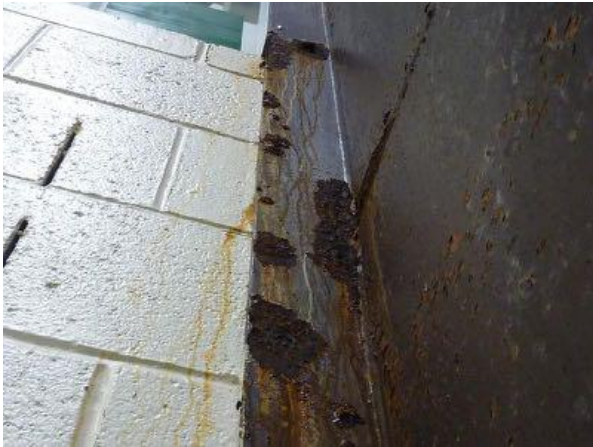
Corroded Gabled Portal Frame Column

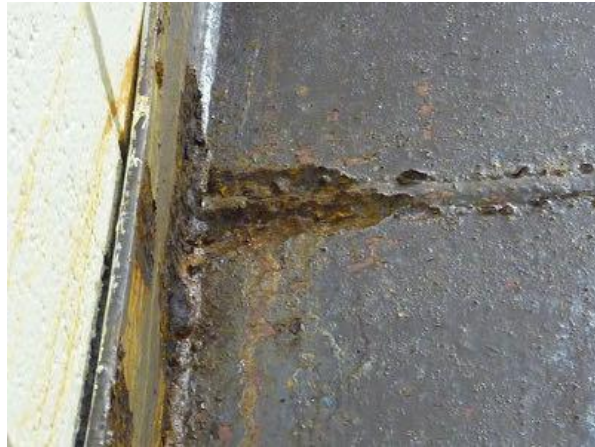
Corroded Gabled Portal Frame Column

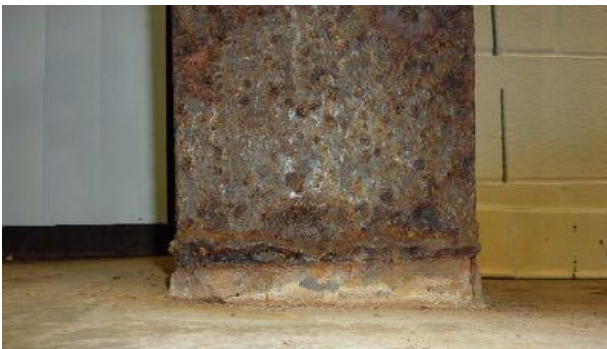
Corroded Gabled Portal Frame Column Base

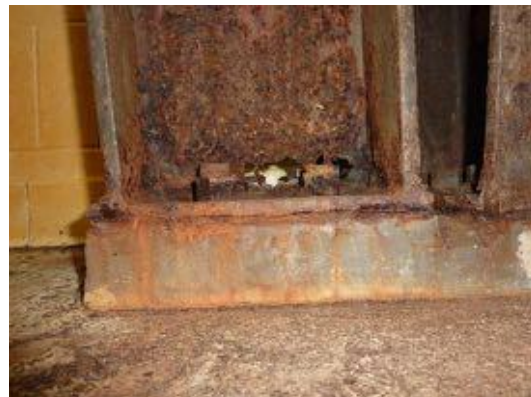
Corroded Flat Portal Frame Column Base
